Norsonic Acoustic Camera

Using acoustic camera inside caravan car to find squeak and rattle noise

Measurements in caravan car, Lier, Norway, October 2015

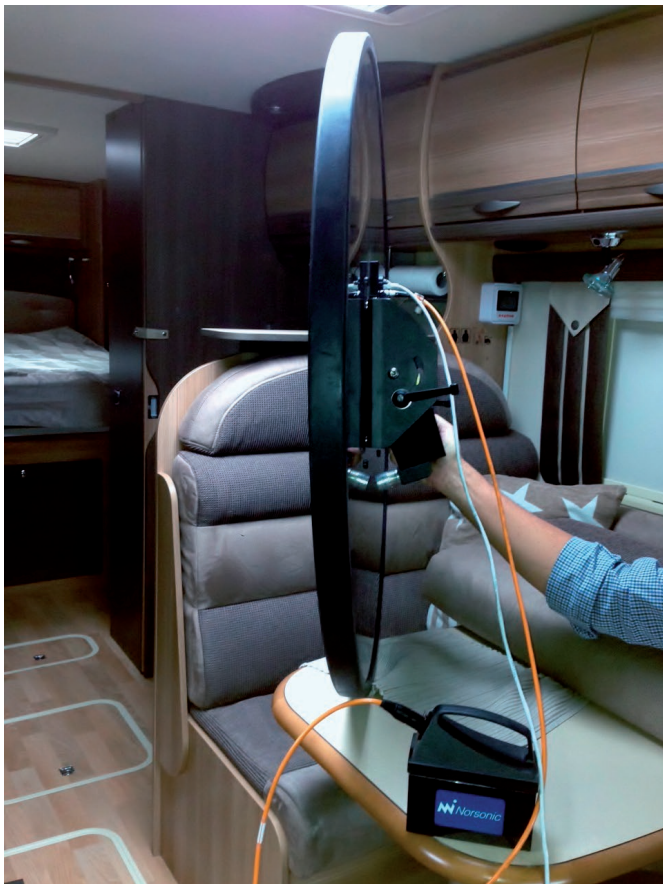
The Norsonic Nor848A-10 1.0m acoustic camera with 256 microphones was used for the recordings. The camera was plugged into an external battery pack for easy transportation and mobility. Although the 40 cm Nor848A-0.4 acoustic camera would have been more mobile, at the time of the measurements it was unavailable. Nevertheless there was more than enough room in the caravan car to use the Nor848A-10.

The measurements were done with one person driving the caravan, and another placing the camera dish on a table and performing the measurements. As the array dish itself weighs in at only 11 kg, it was easy to control it with one arm, and starting and stopping a measurement in the software on the MacBook with the other arm. No tripod was used or needed for the measurements.

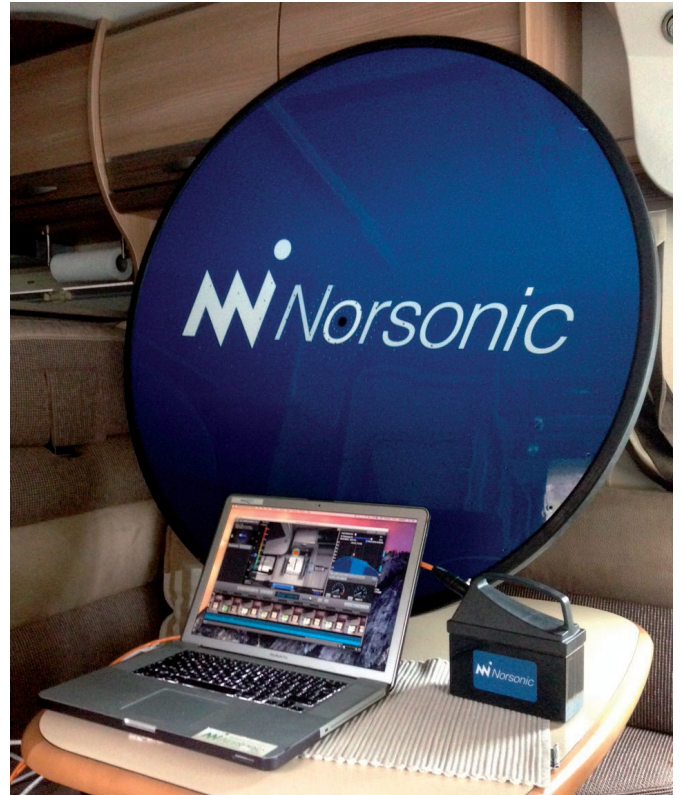
Initially the camera was pointed towards the fridge in the center of the living compartment of the caravan and measurements were made as this was thought to be the origin of the sources. In addition to looking at the coloring of the sources, it was also very useful to use the virtual microphone to listen to the sound field from a specific

direction. In addition it worked very well to enable the band pass filter when listening in order to filter out background noise such as engine noise and wheel noise.

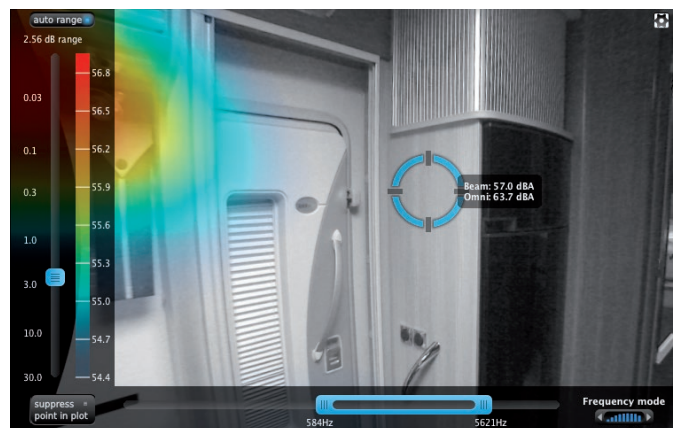
Seen in the image below is the initial result when filming at the fridge in the living compartment of the caravan with the caravan driving and turning, and when the distinct metal rolling sound was heard. As seen from the image there was no indication whatsoever that the sound originated from the fridge in the middle of the picture. Instead the coloring indicated that the sound originated from a different location. Also listening with the virtual microphone could more or less rule out the possibility that the fridge was the source origin. Instead the camera was positioned to aim to the left of the fridge where the coloring indicated a source. The position of the true source was seen more or less

instantly to be inside a cabinet positioned on the wall of the car. This true source location was also confirmed when listening with the virtual microphone on a recording, and even when holding the ear into the cabinet when driving.
